1

Development Perspectives

Derek J.W. McMinn

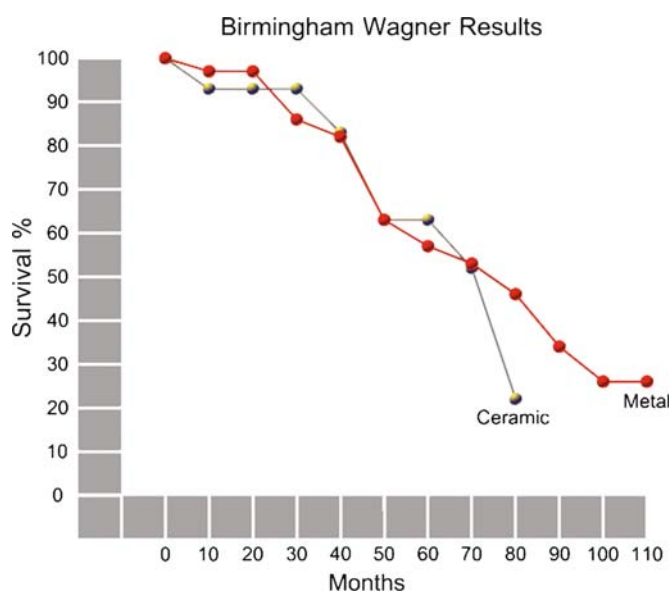
FIG. 1.1. Poor results on survivorship analysis with the ceramic on polyethylene and metal on polyethylene resurfacings performed in Birmingham.

Hip arthritis in its early stages involves the loss of a few millimeters of articular cartilage on the femoral head and acetabulum. From the pioneering hip resurfacing work of Charnley using double cups of Teflon (more correctly, polytetrafluoroethylene) in the 1950s right through to the end of the 1980s, surgeons were attracted to the resurfacing concept with replacement only of the worn-out parts. Over these 40 years, however, the major problem was excessive wear of the resurfacing materials, and the hip resurfacing operation fell into disrepute. I was able to witness the problem of wear of the bearing parts in my revision practice when large numbers of Wagner resurfacings had to be converted to total hip replacements (Figs. 1.1–1.3).

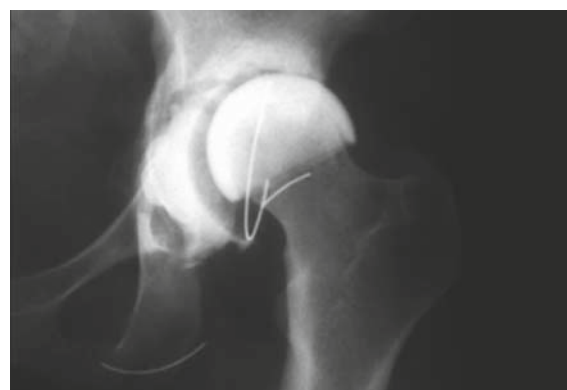
FIG. 1.2. Common form of failure in ceramic on polyethylene resurfacing. Linear osteolysis has loosened the acetabular component, which migrated into a vertical alignment. Severe wear of the acetabular component edge occurred with fracture of the peripheral metal cup marker.

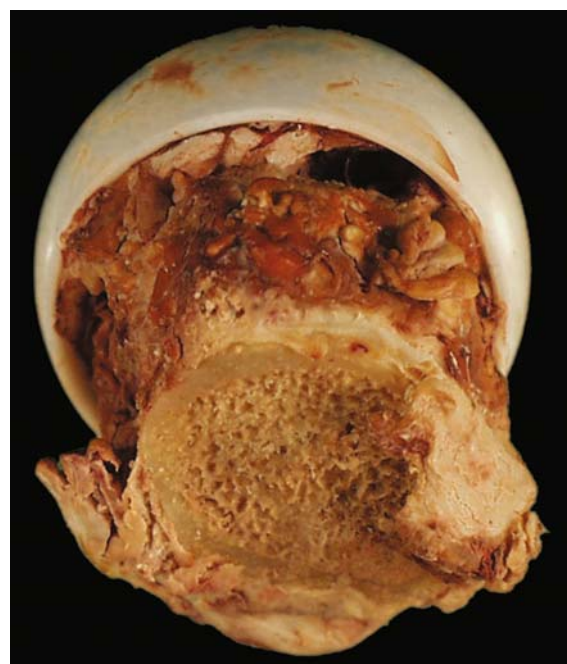
FIG. 1.3. Femoral head and neck removed at revision surgery with solidly fixed ceramic femoral component. Loose acetabular cup and acetabular osteolysis necessitated revision 9 years after implantation.

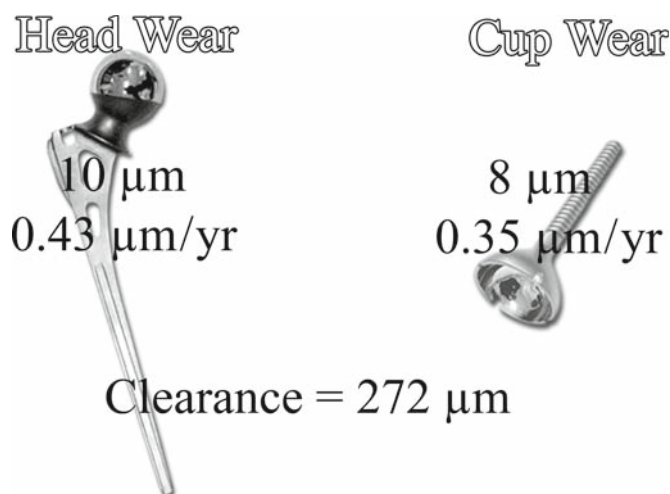
FIG. 1.14. Wear and clearance measurements of the components removed from the patient of Fig. 1.13.

In this patient, who was known to be active, remarkably little wear of the bearing parts has occurred with only 10-μm wear on the femoral head and 8-μm wear on the acetabular component. This represents 0.43 μm per year wear on the femoral head component and 0.35 μm per year wear on the acetabular component (Fig. 1.14). The diametral clearance on this bearing was 272 μm, and with the current state of knowledge this would be regarded as a large clearance. The lack

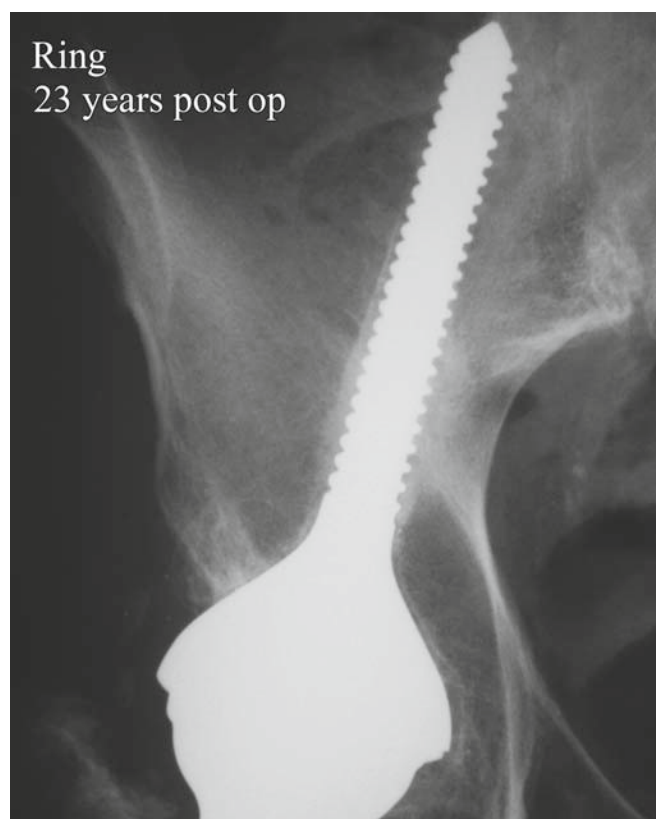
FIG. 1.15. Radiolucent line around smooth Ring cup. Another patient with interface access but no osteolysis.

of osteolysis around the acetabular component in this patient with proven acetabular component loosening gives support to the view that normal low wear from these metal on metal bearings does not cause osteolysis (Fig. 1.15).

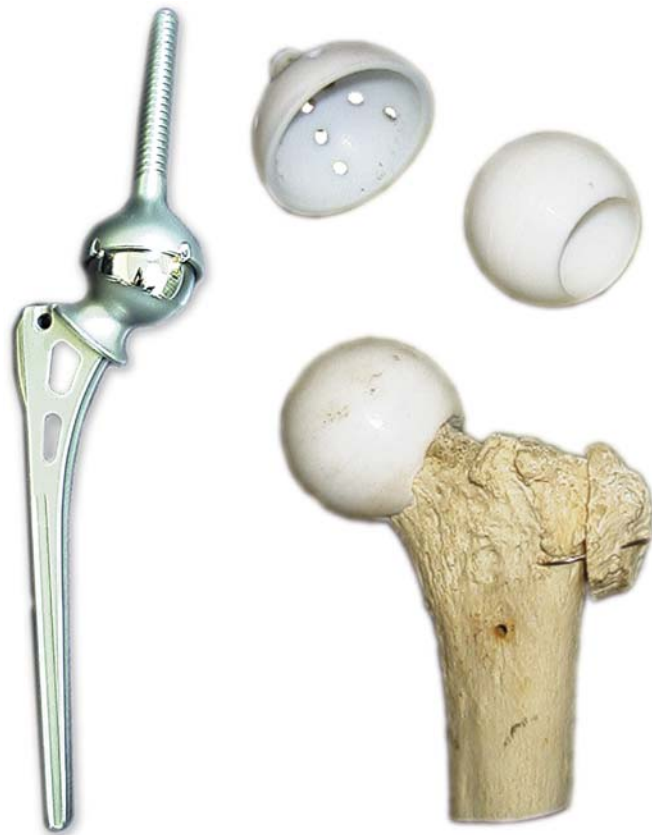
FIG. 1.20. Combining metal on metal bearings with Charnley's hip resurfacing concept proved a hard sell.

There remained only the problem of convincing other surgeons and an implant manufacturer that combining two unattractive ideas would make an attractive implant (Fig. 1.20)!

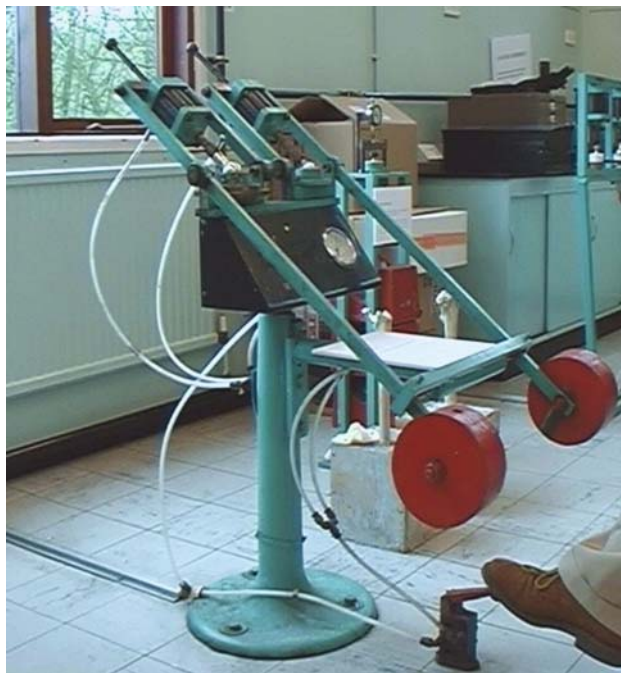
FIG. 1.22. Charnley pendulum comparator.

couple under test is lined up with the center of rotation of the two outer roller bearings. The direction of load on this pendulum comparator is distinctly odd and quite different to the loading in the normal hip as Charnley's own work showed. In the pendulum comparator, the load is directed through the femoral component with the head-cup contact area moving in an arc described by the amplitude of the pendulum. This would give a multidirectional cup wear pattern, and Charnley knew that this did not occur in the human hip.

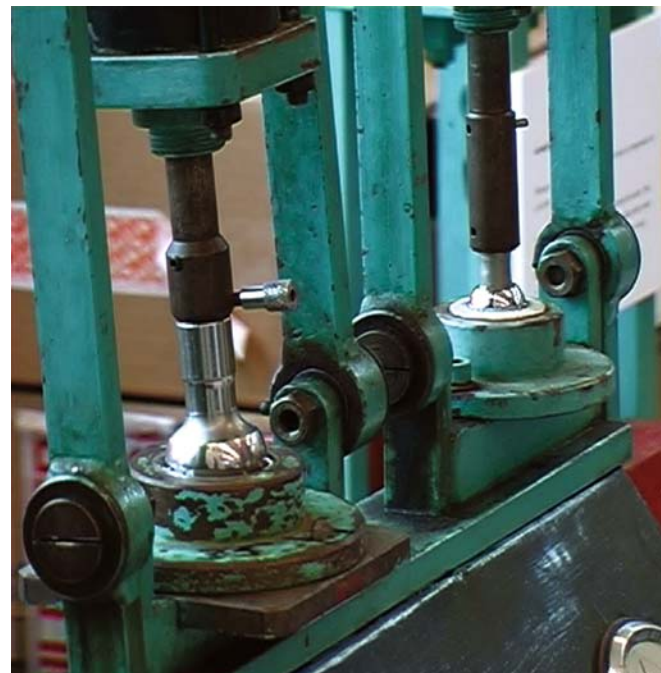
FIG. 1.23. The McKee-Farrar metal on metal couple (nearest) came to a juddering halt despite the application of human synovial fluid, and the Charnley metal on polyethylene couple (farthest) kept on swinging.

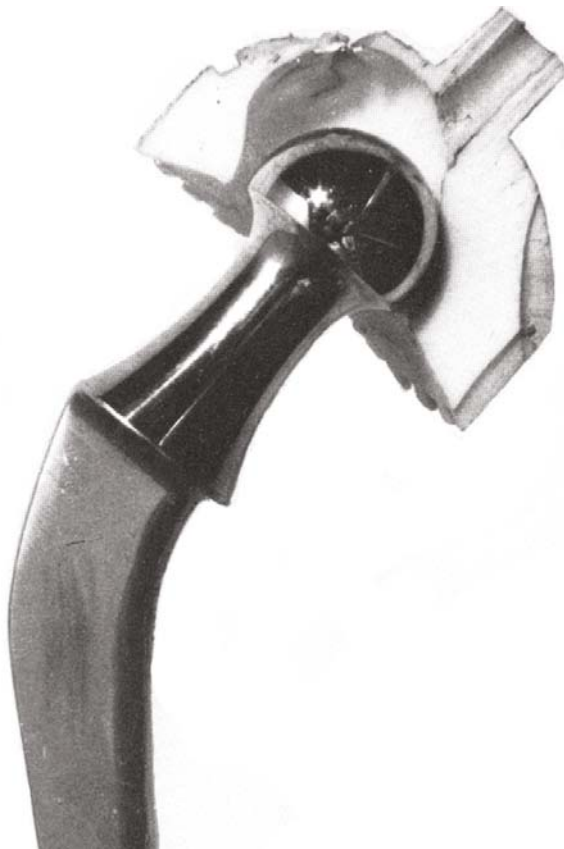
FIG. 1.24. Total wear-through of a Charnley Teflon cup after 3 years showing vertical direction of wear track. (Reproduced with permission from Springer).

In a high-wearing polymer, such as the Teflon cup used by Charnley from 1958–1961, the direction of loading and wear can easily be appreciated (Fig. 1.24). The loading is in one direction, unlike Charnley's pendulum comparator where the loading is multidirectional. This may have implications for the lubrication and performance of metal on metal bearings.

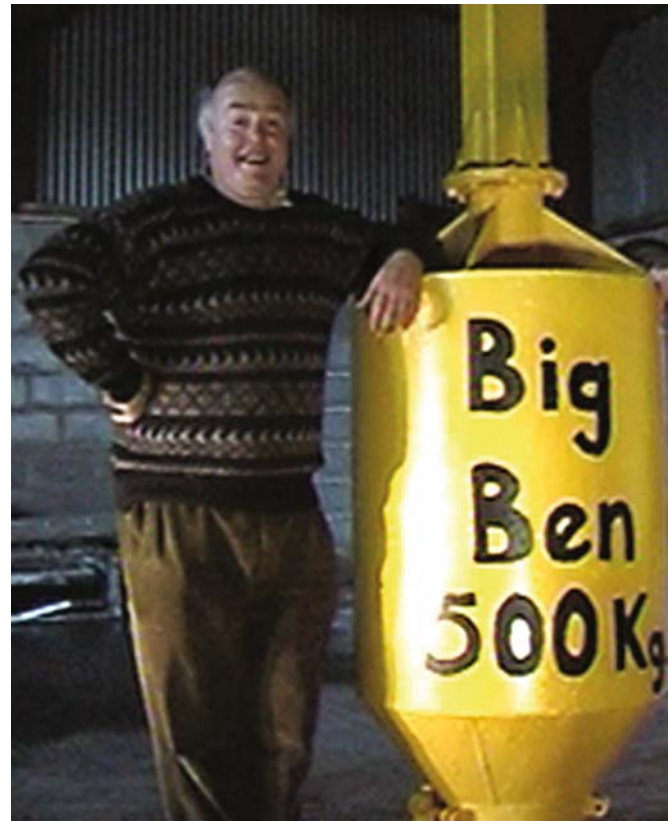
FIG. 1.25. Author standing beside 500-kg concrete-filled steel bob. This weight was necessary to give realistic high loading on prosthetic hip joints.

We built a small pendulum that performed much better with metal on metal joints than did Charnley's apparatus. However, I could not rest until I had a pendulum apparatus constructed that loaded the hip joint in a more satisfactory fashion than did Charnley's pendulum comparator and also did not have the hazards of Charnley's two roller bearings incorporated in the apparatus. The pendulum furthermore had to load the hip joint to 500 kg, and the metal on metal articulation under test would have to be manufactured to modern standards (Fig. 1.25).

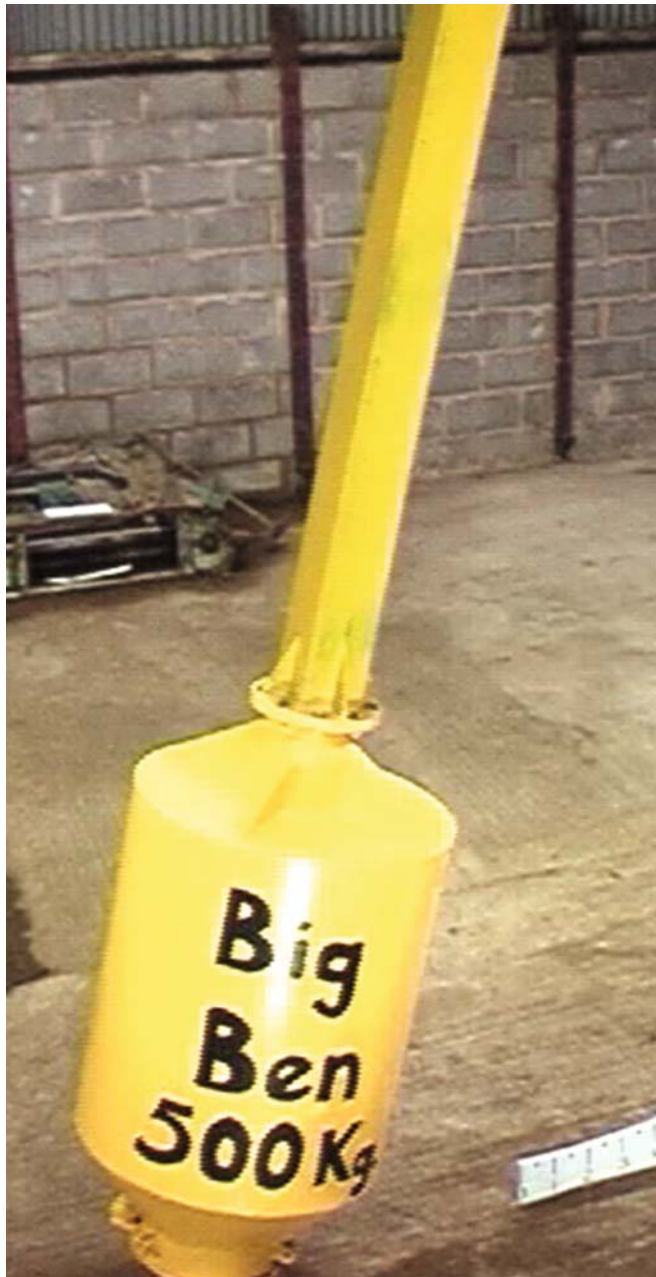
FIG. 1.26. Big Ben in action. Happily, the calculations of the structural engineers were correct, and the pendulum did not cause collapse of the building.

Until we started building this pendulum, I had not fully appreciated what a massive load 500 kg is. In addition, observing this monster pendulum swinging makes one appreciate how clever the normal hip joint design is to cope with these huge loads (Figs. 1.26–1.28).

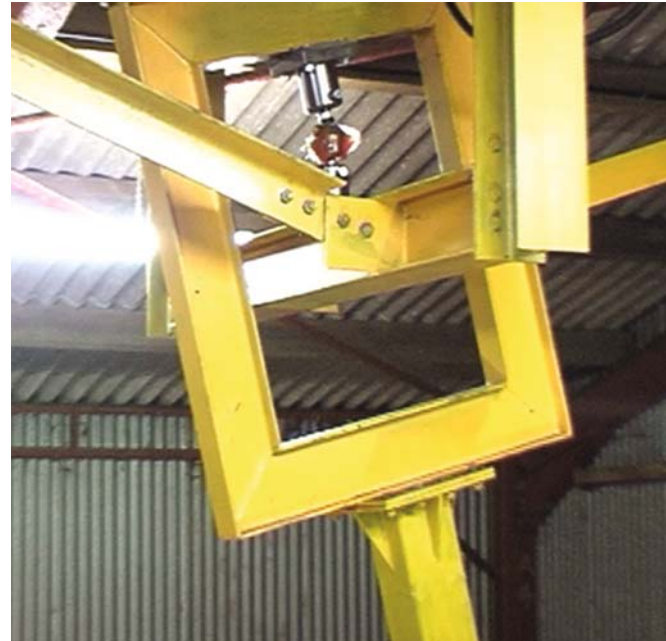
FIG. 1.27. Loading area for test hip joint prostheses high in roof space. When stationary, a hydraulic ram is attached to distract the apparatus and load a new joint for testing.

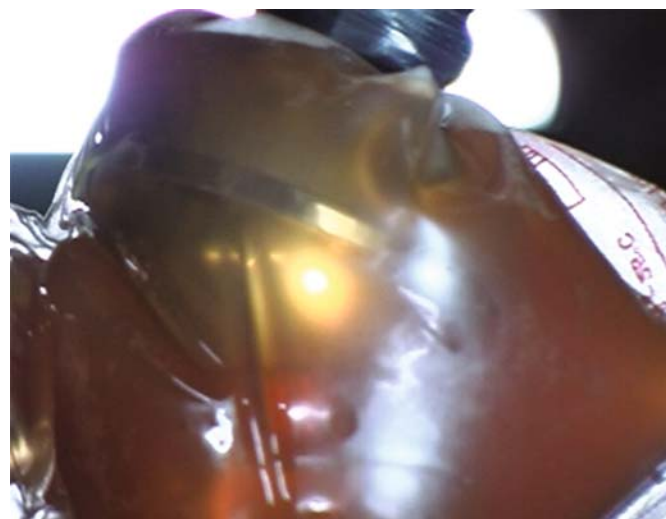
FIG. 1.28. This shows metal on metal couple with the acetabular component on top. Outside the prosthesis is a membrane containing serum and hyaluronic acid.

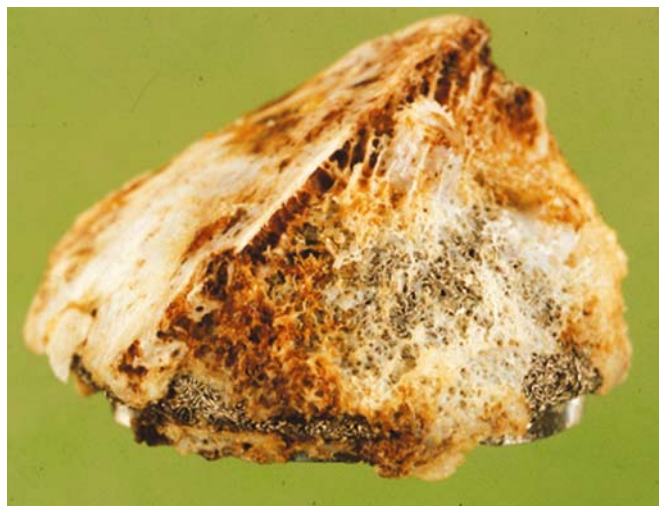
FIG. 1.30. Harris-Galante I cup shell together with osseointegrated acetabulum removed at revision surgery.

Fixation, however, has never been a problem with this implant. One of my patients developed recurrent dislocation and ended up being revised elsewhere by a surgeon who believed that uncemented fixation was not very powerful. An attempt was made to remove the cup shell without first breaking down the implant-bone interface. The surgeon extracted the cup but also removed the rest of the acetabulum, which he discovered was very powerfully attached (Fig. 1.30).

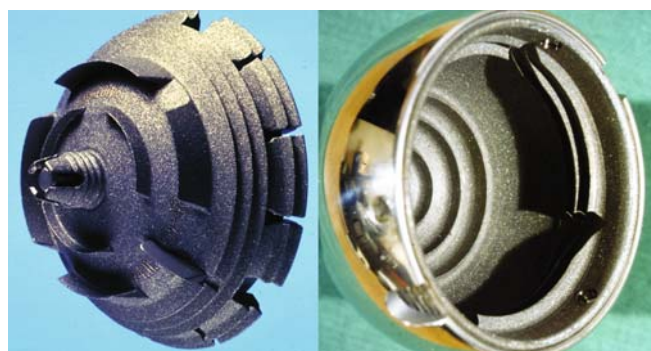
FIG. 1.34. Initial variety of cementless metal on metal resurfacing. Cup and head had porous titanium ingrowth surfaces with cobalt chrome articular surfaces. Femoral component was of a “screw-on” type.

Heinz and Michael Wagner inserted two varieties of metal on metal resurfacing and reported their results in 1996 [9] (Figs. 1.34 and 1.35). Heinz and Michael Wagner eventually abandoned hip resurfacing due to fixation problems.

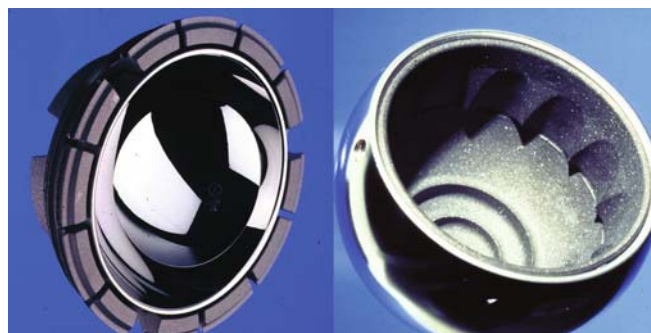
FIG. 1.35. Second variety of cementless implant with femoral component changed to impacted press-fit type. (Images courtesy Prof. Michael Wagner, MD, PhD.).

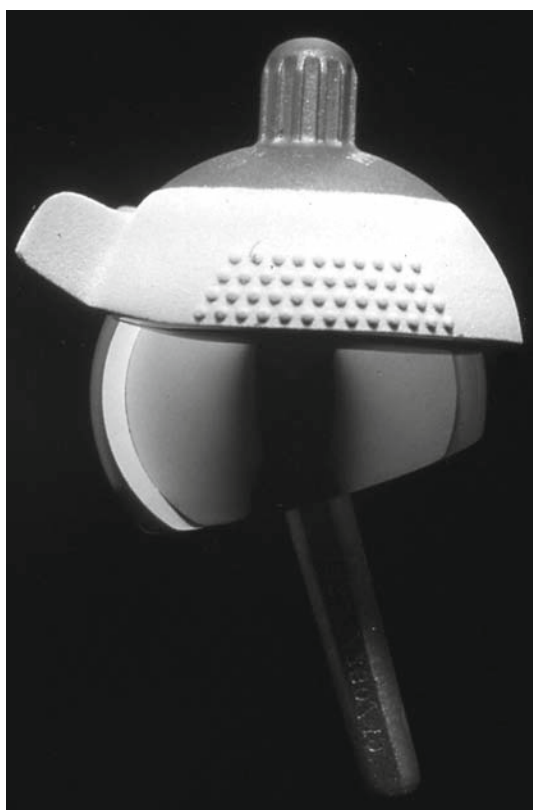
FIG. 1.39. HA-coated head and cup.

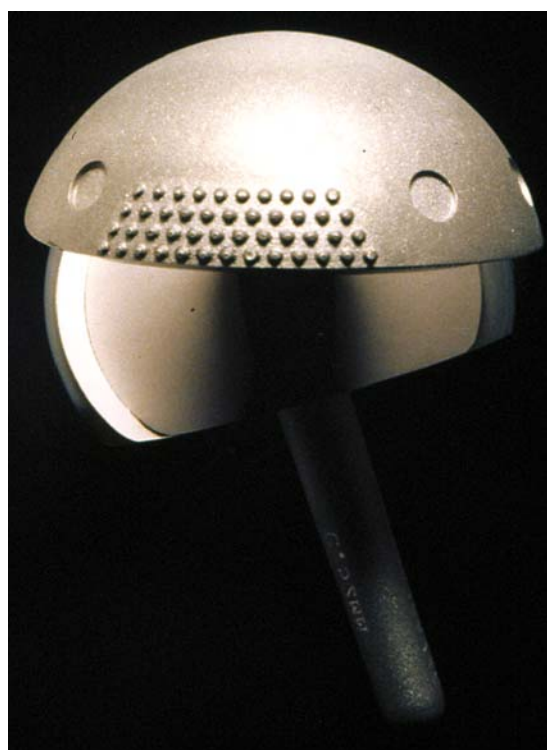
FIG. 1.41. Cemented cup and femoral components. Recesses in cup for cement fixation.

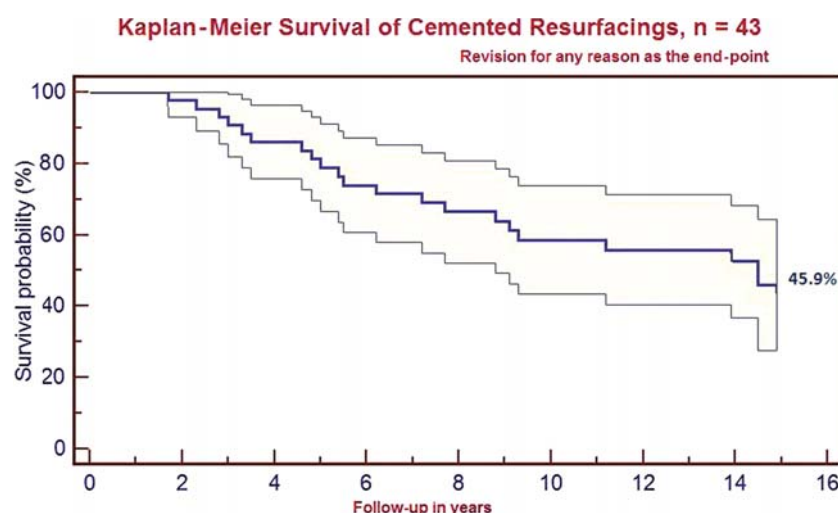
FIG. 1.42. Very poor results with cemented cup, cemented head resurfacings due to acetabular failure.

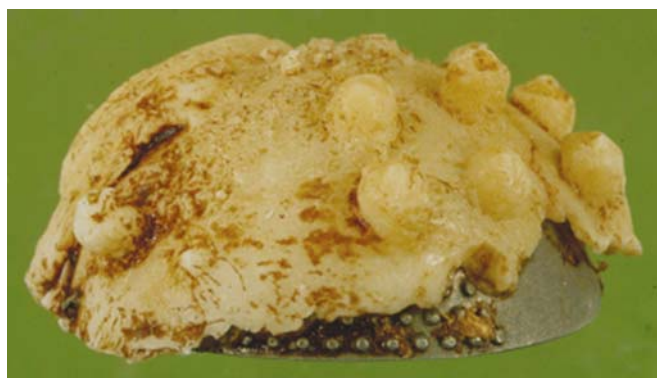
FIG. 1.44. Cemented cup removed for loosening.

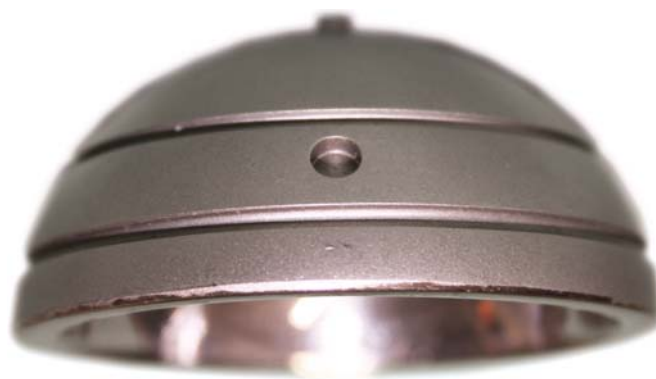
FIG. 1.48. Deeper fixation features for cemented cup provided for Dr. Amstutz.

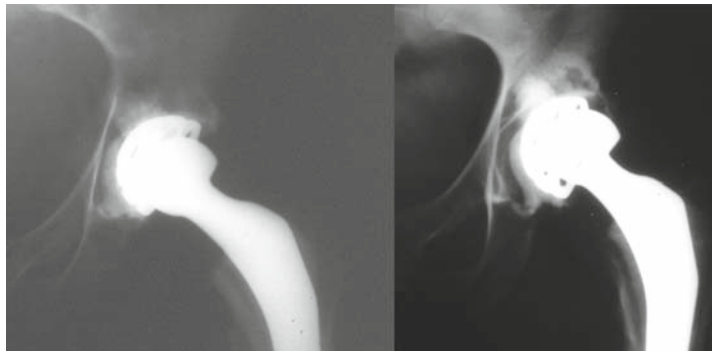
FIG. 1.50. Postoperative x-ray of Exeter metal-backed cemented cup and accelerated loosening at cement-bone interface.

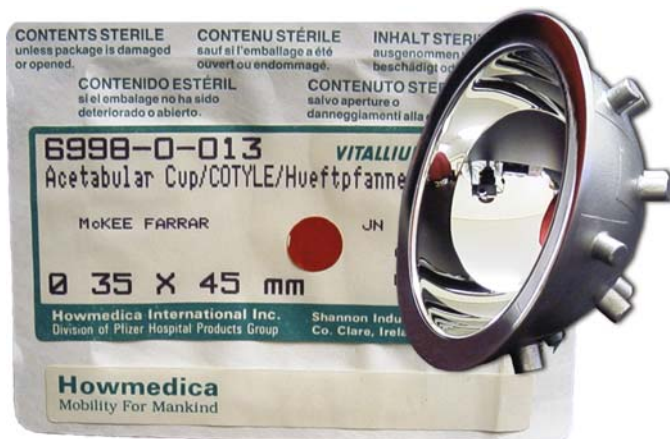
FIG. 1.51. Spikes on the back of McKee-Farrar cup with its original box.

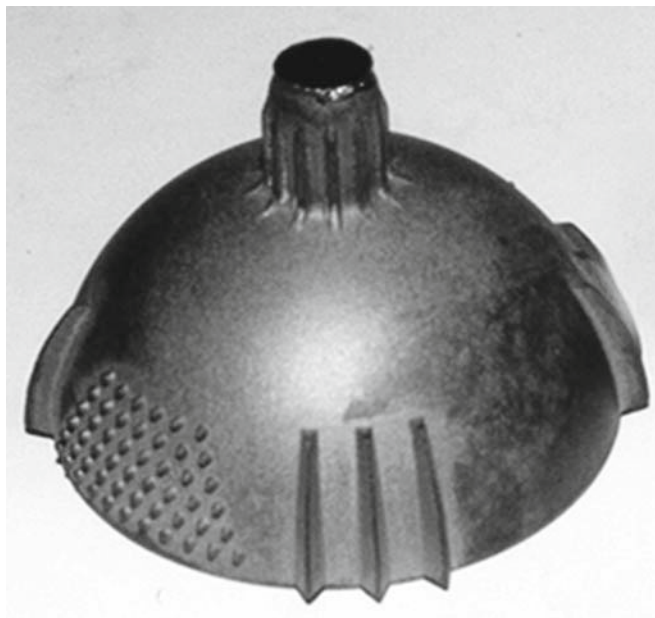
FIG. 1.52. New variety of cup before HA coating. Three of the four sets of antirotation fins can be seen.

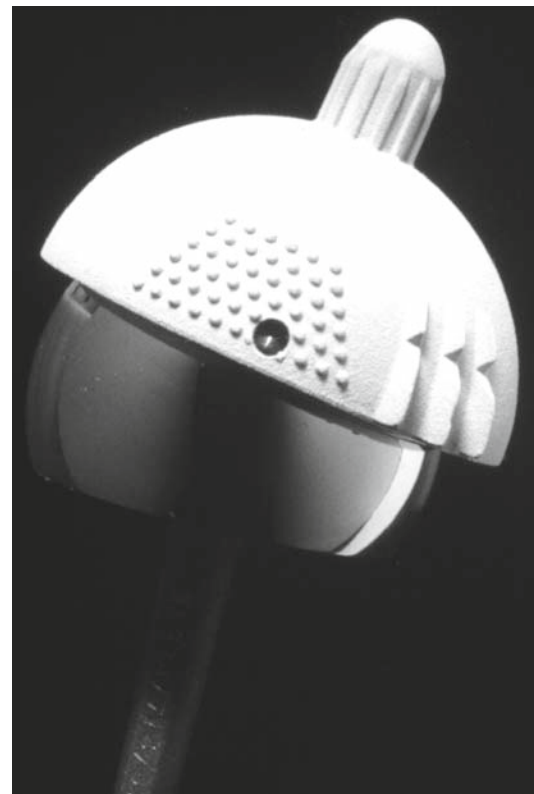
FIG. 1.53. McMinn Hybrid Resurfacing used from March 1994 to December 1996.

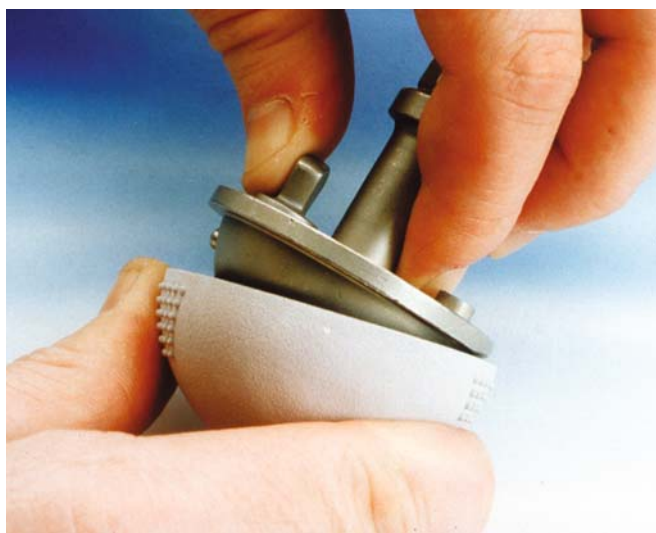
FIG. 1.56. Cup introducer being attached to acetabular component. Two locking pins hold the cup on.

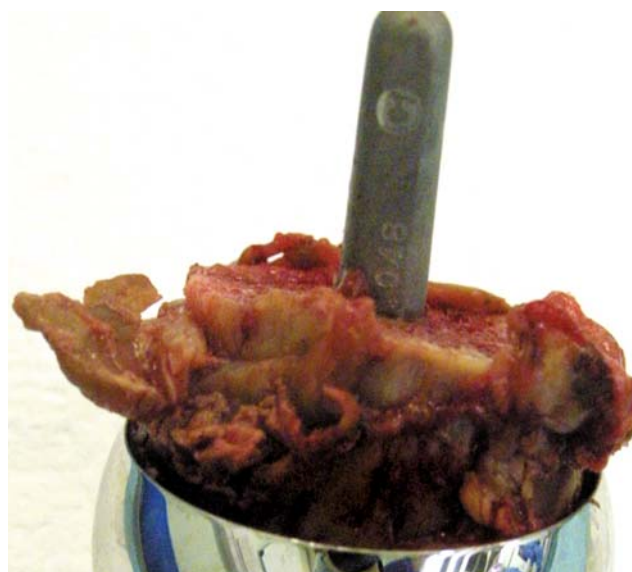
FIG. 1.59. Metallosis staining of soft tissue around femoral neck at revision of 1996 McMinn Hybrid Resurfacing. The patient had osteolysis and cup loosening.

The mode of failure in a vast majority of the 1996 series was metallosis, osteolysis, and acetabular component loosening (Figs. 1.59 and 1.60).

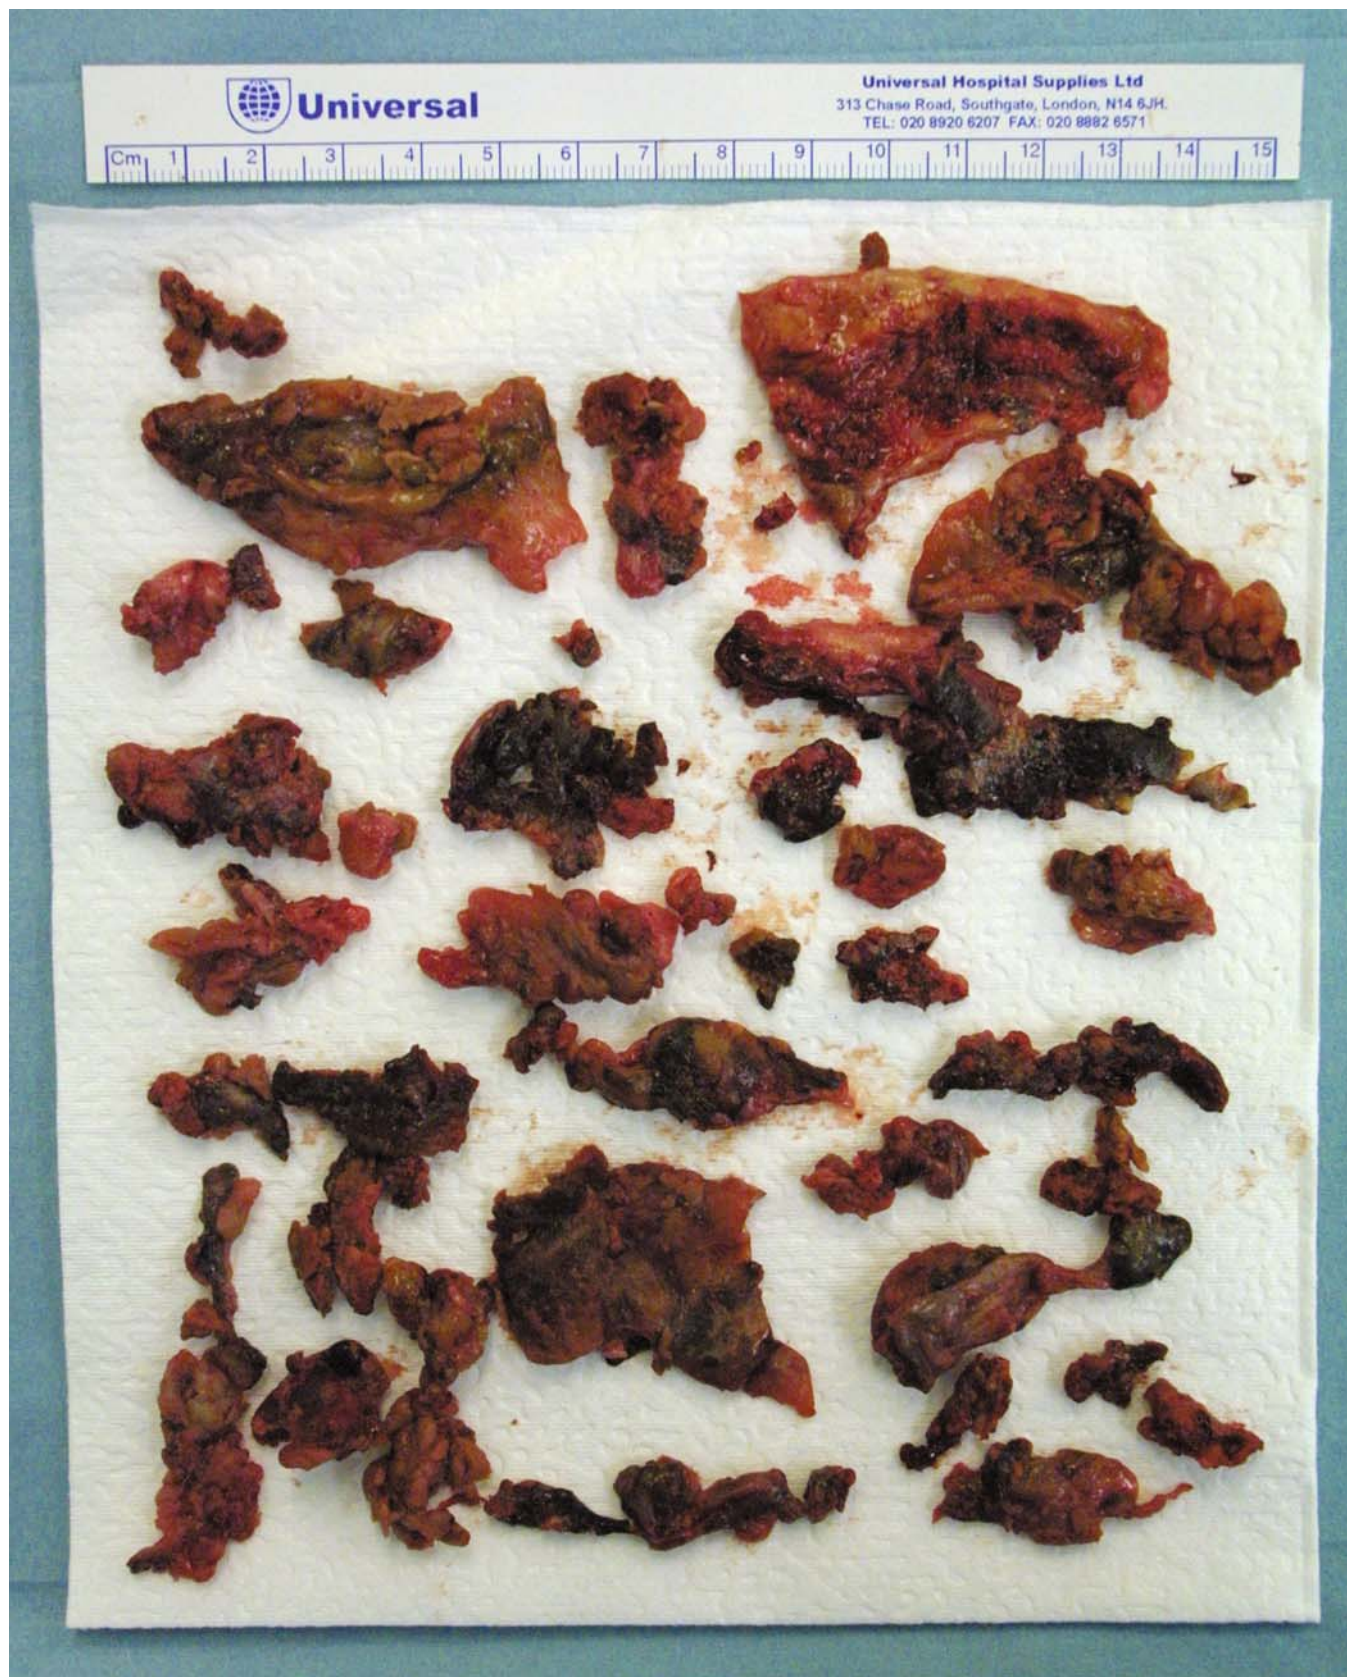
FIG. 1.60. Same patient as that of Fig. 1.56 showing the extent of metallosis in capsule and acetabular pseudomembrane.

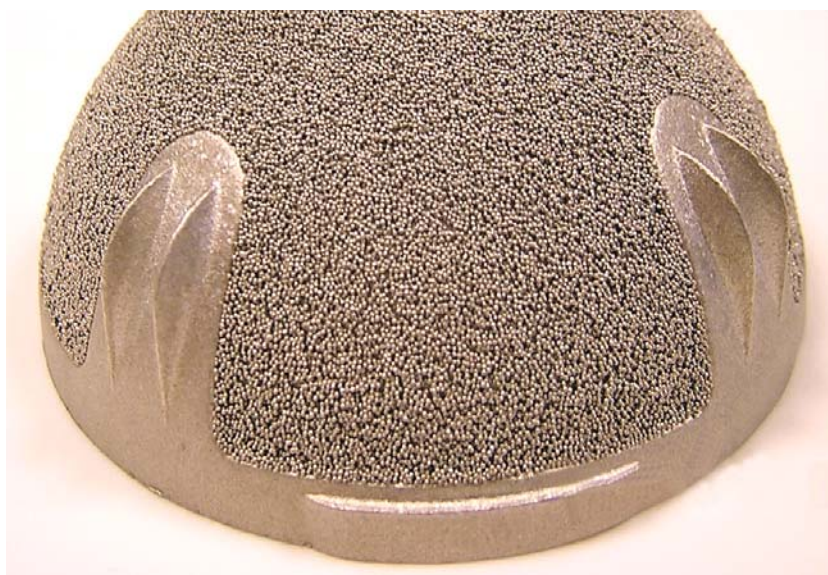
FIG. 1.64. Sintered beaded BHR cup. Because of microstructural damage of the metal, this implant was never used clinically.

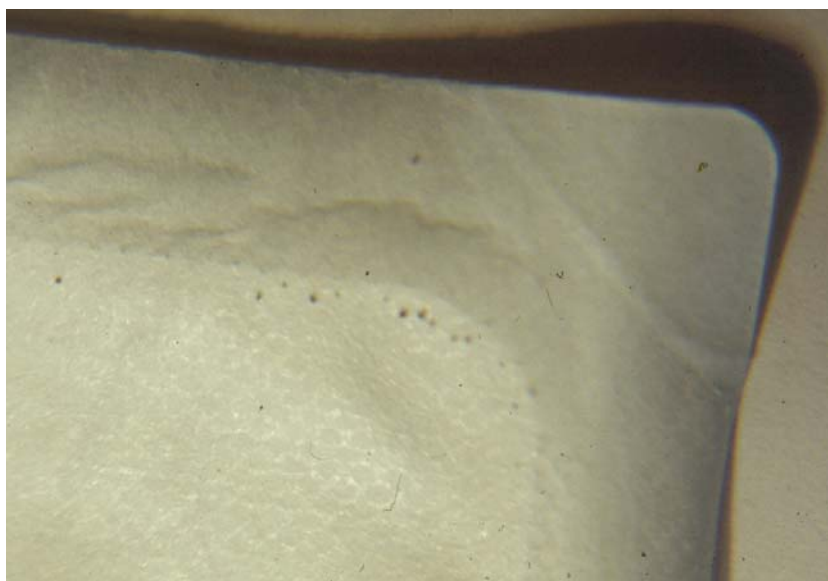
FIG. 1.65. Plasma-sprayed titanium particles in packaging box having fallen off the porous surface of an acetabular cup.

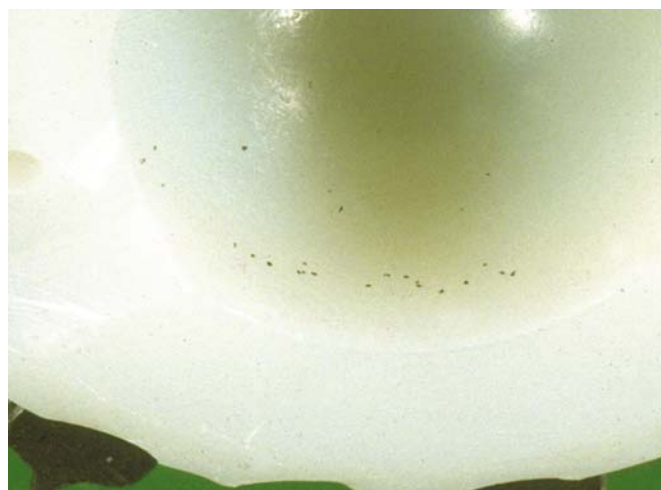
FIG. 1.66. Polyethylene liner removed at revision with embedded plasma-sprayed titanium particles. Plasma-sprayed acetabular shell was solidly fixed.

titanium coating migrate into the articulation in my revision practice (Fig. 1.66).

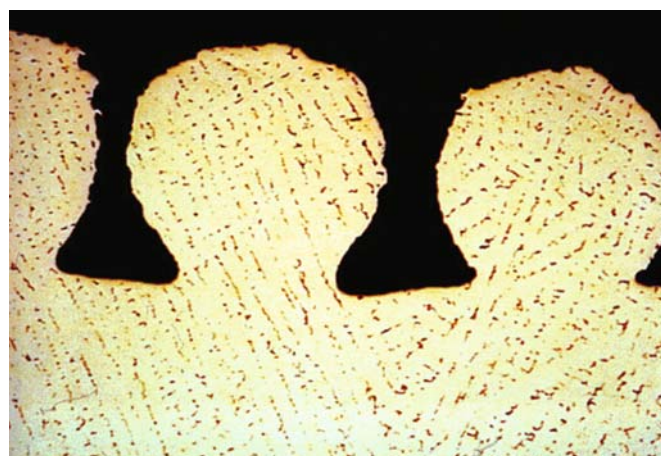
FIG. 1.67. Section through Porocast beads and cup substrate metal. Beads are integral with cup substrate metal. Carbides (dark dots) in microstructure can be seen.

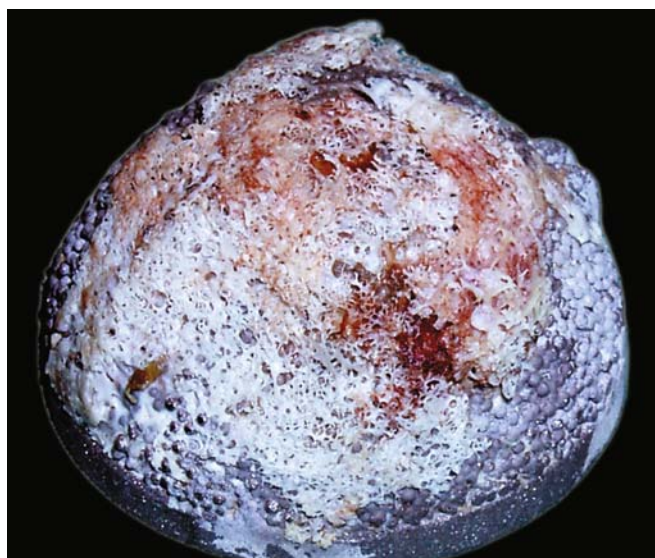
FIG. 1.68. Extensive bone on-growth. BHR cup removed at Girdlestone excision for hematogenous infection 3 years postoperatively

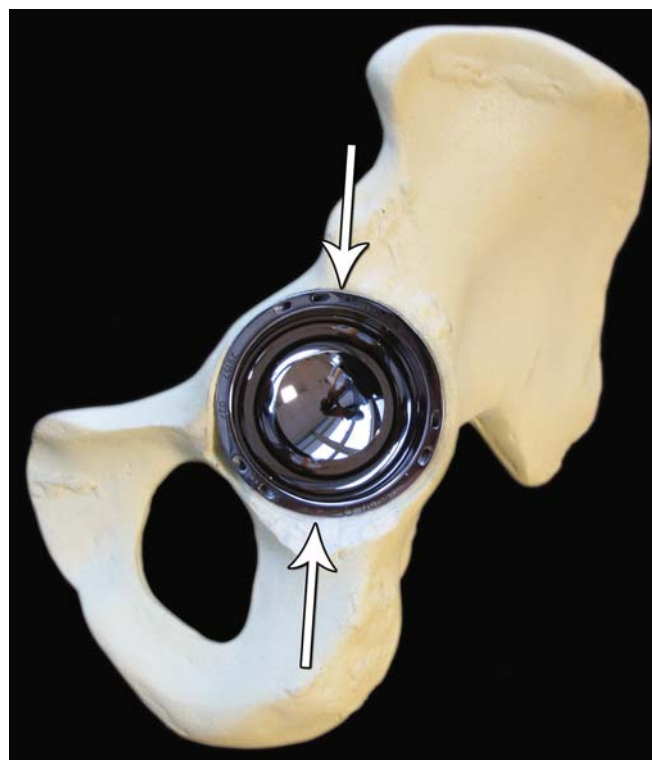
FIG. 1.74. With press-fit cementless cups, compression occurs between anterior inferior spine and ischium (arrows).

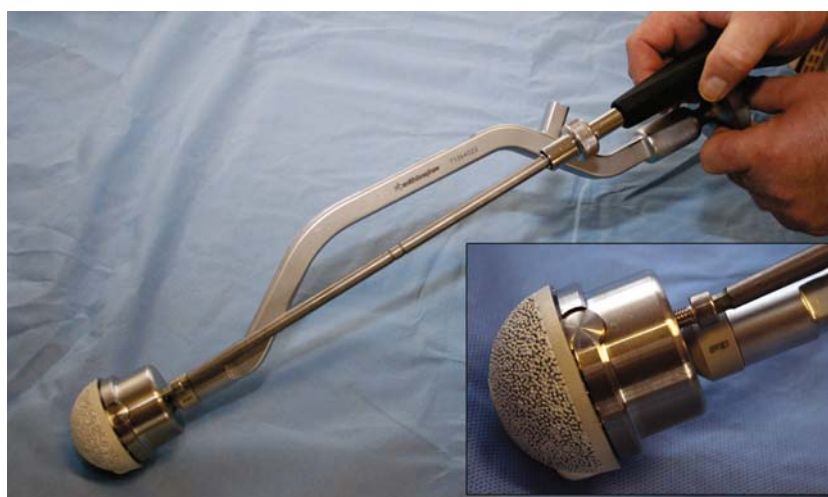
FIG. 1.75. Equipment for measurement of intraoperative cup deformation.

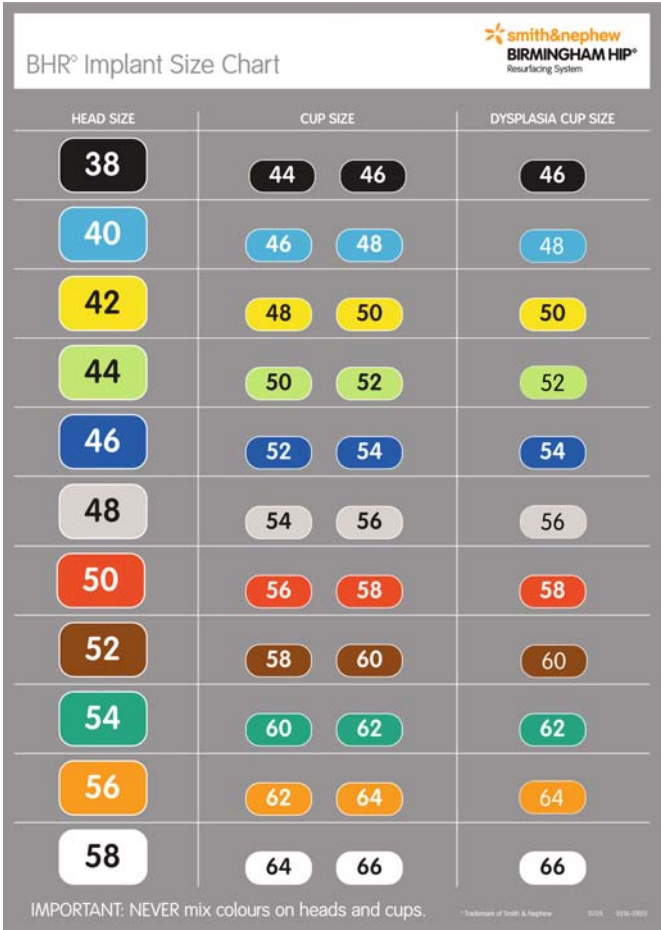
FIG. 1.77. Two-millimeter-increment Birmingham Hip Resurfacing sizing chart.
